Visual Inspection Report for [address deleted]

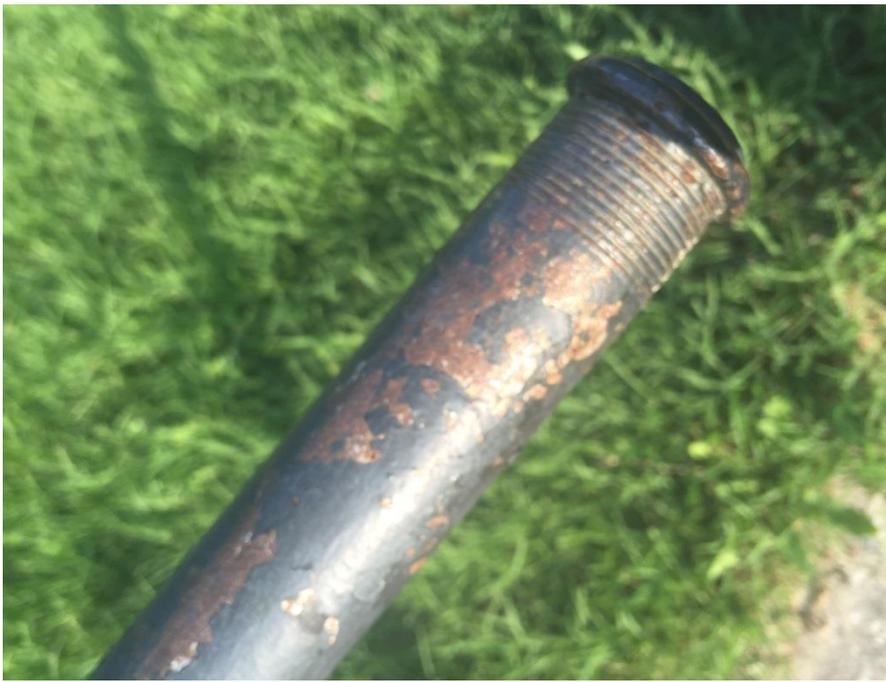
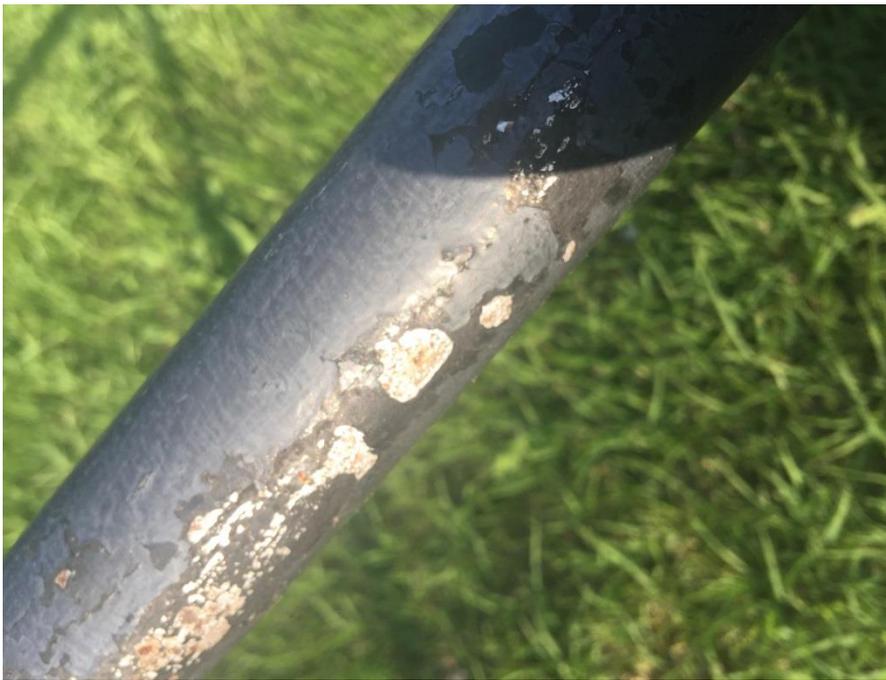
Examples of paint deteriorating on the hand railing of the stairs leading up to the home.

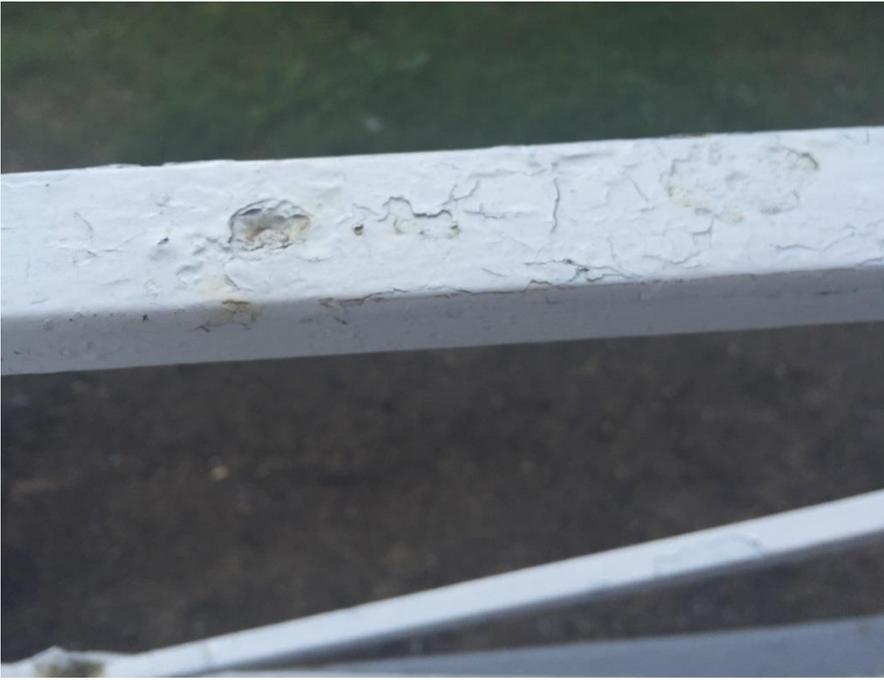
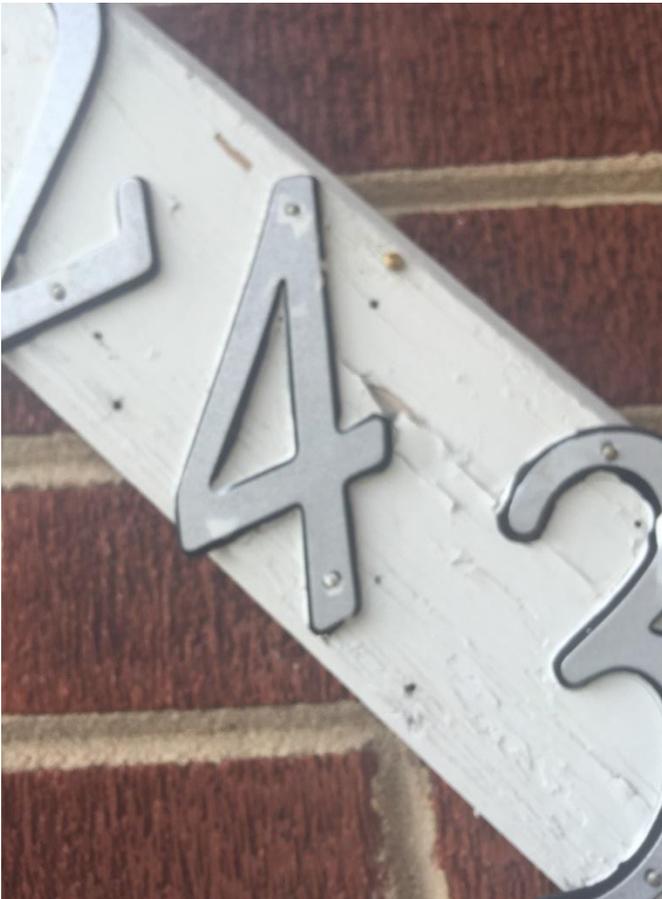
Paint deteriorating on the hand rail and address board outside of the front door.

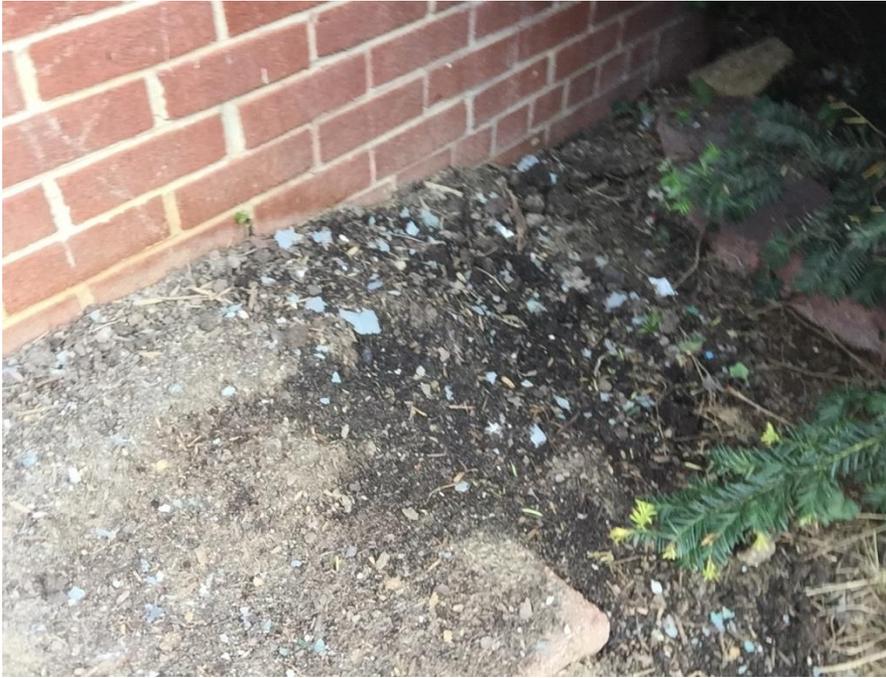
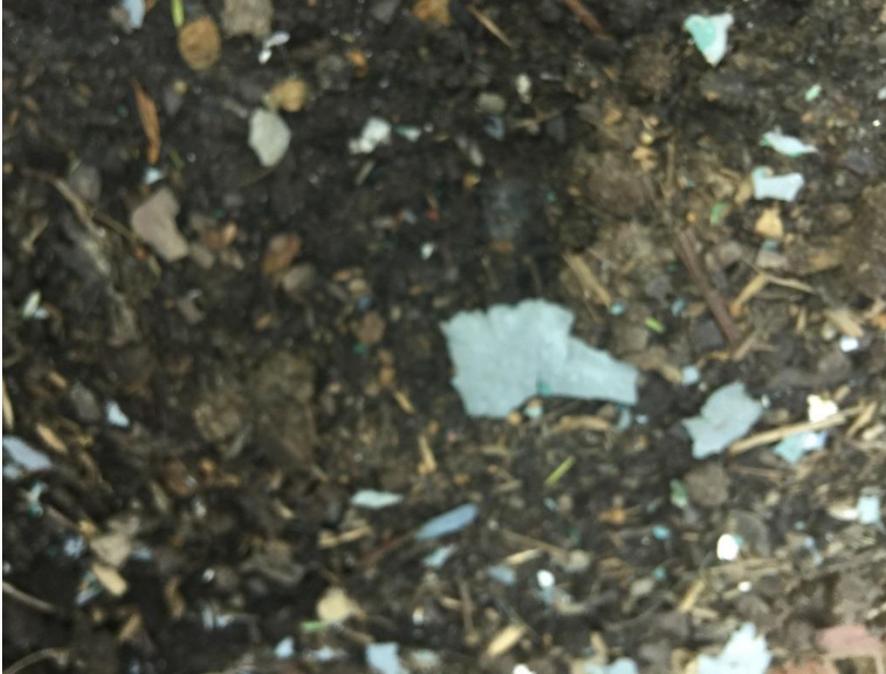
There can not be any deteriorated paint chips on the ground inside or outside of the home.

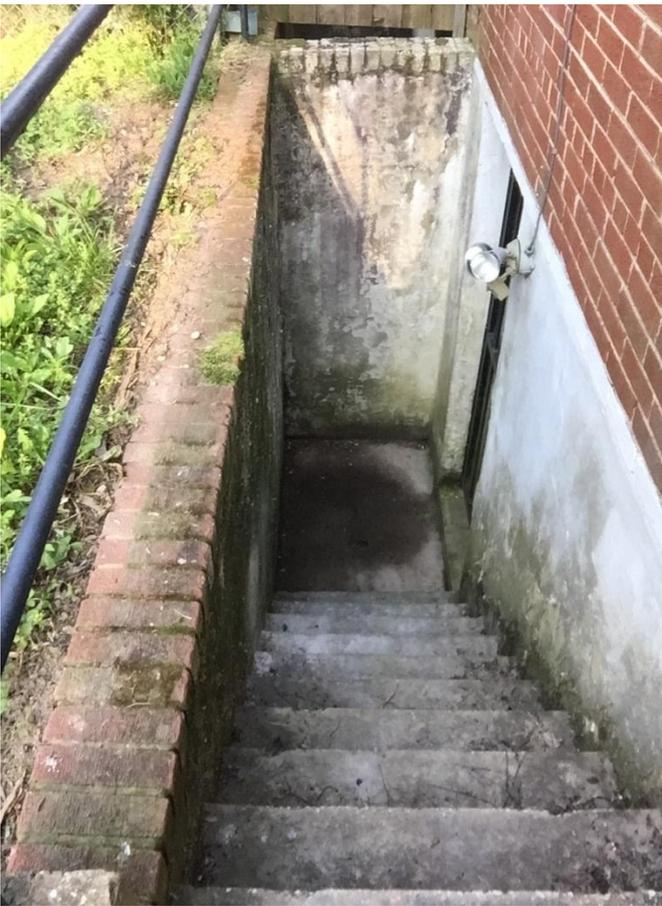
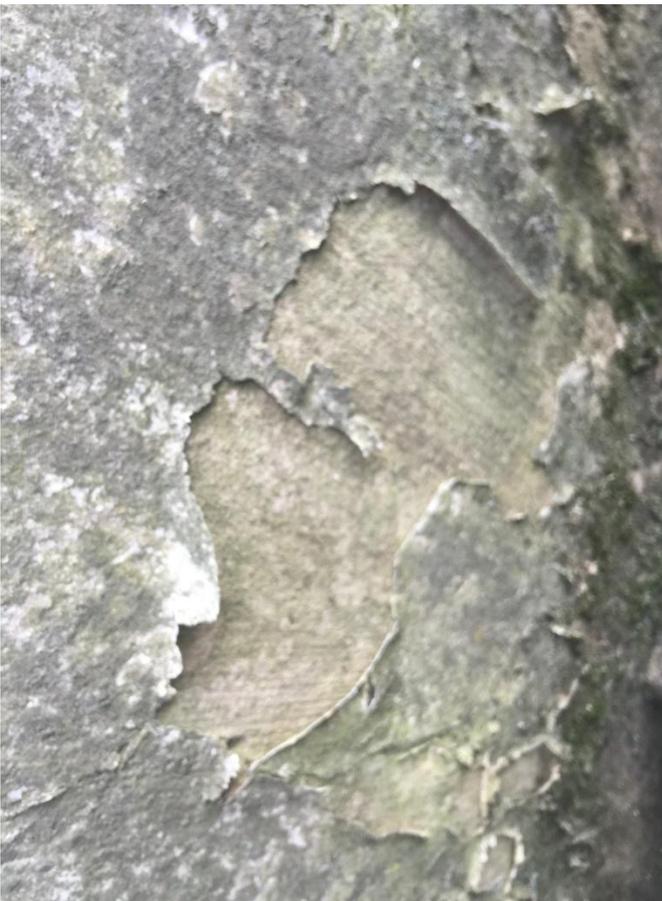
Example of paint deteriorating in the back stairwell. All of the walls were damaged, and had paint chipping off of them.

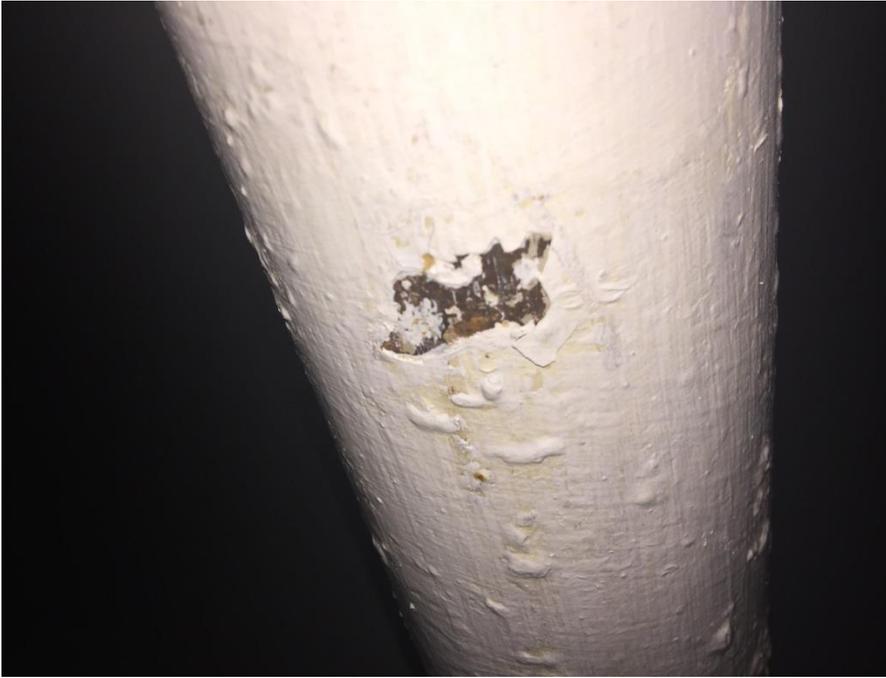
Example of paint chipping and deteriorating on one of the poles in the basement.

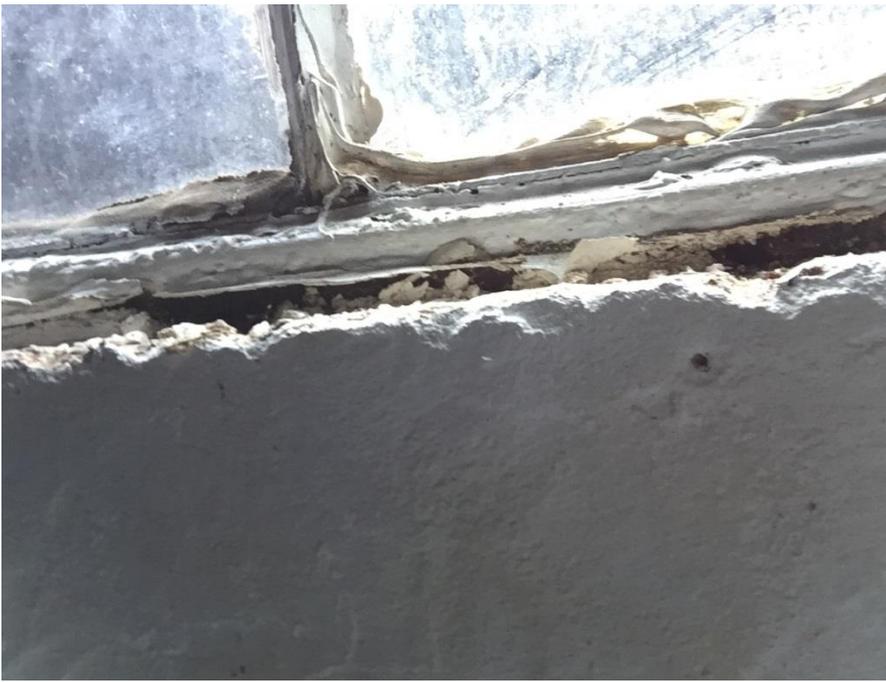
Example of paint flaking on a window sill in the basement.

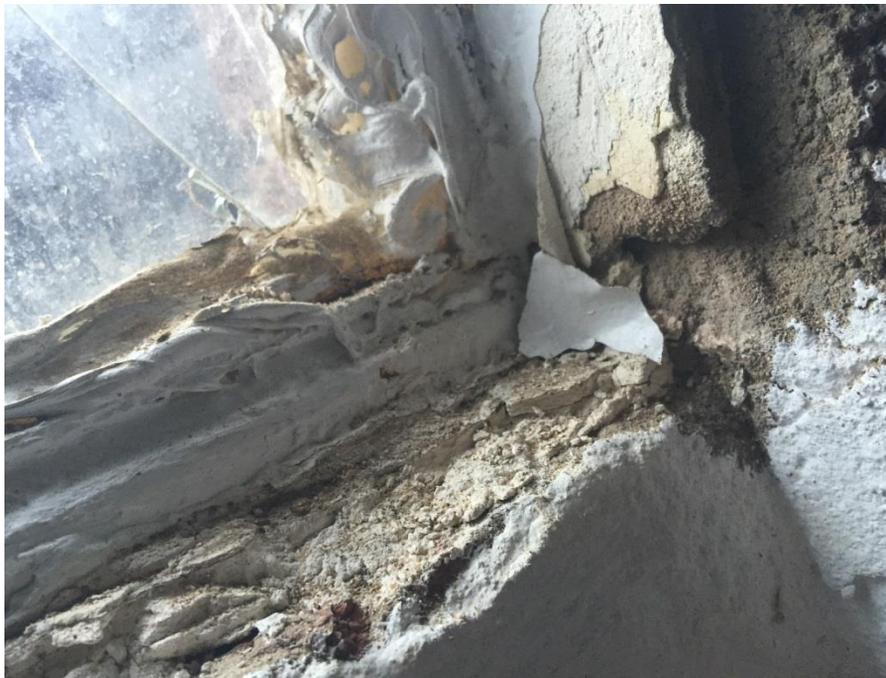
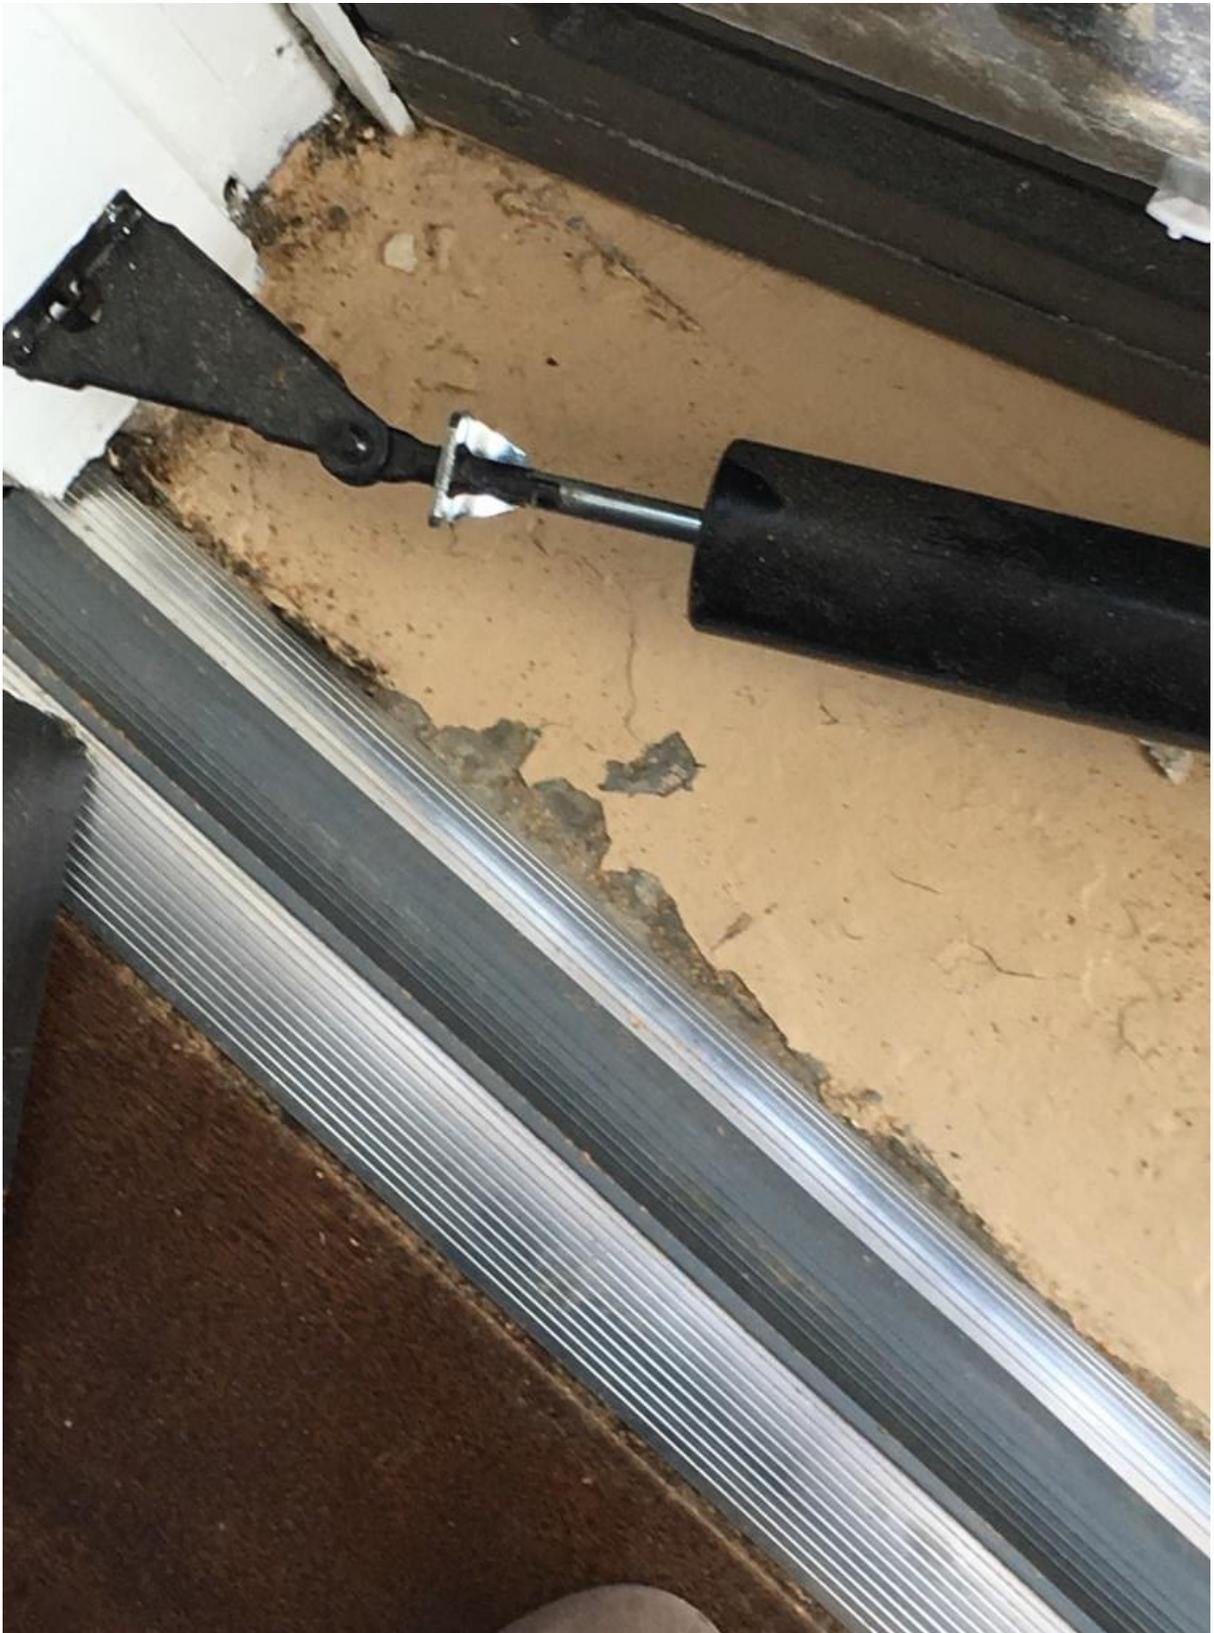
Paint deteriorating on step outside of the front door.

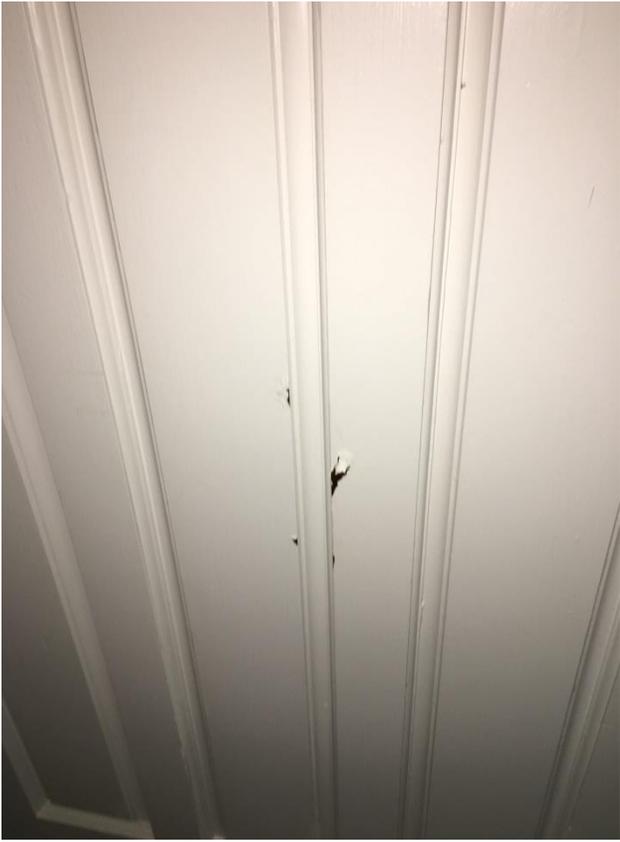
Paint peeling on the door and banister.

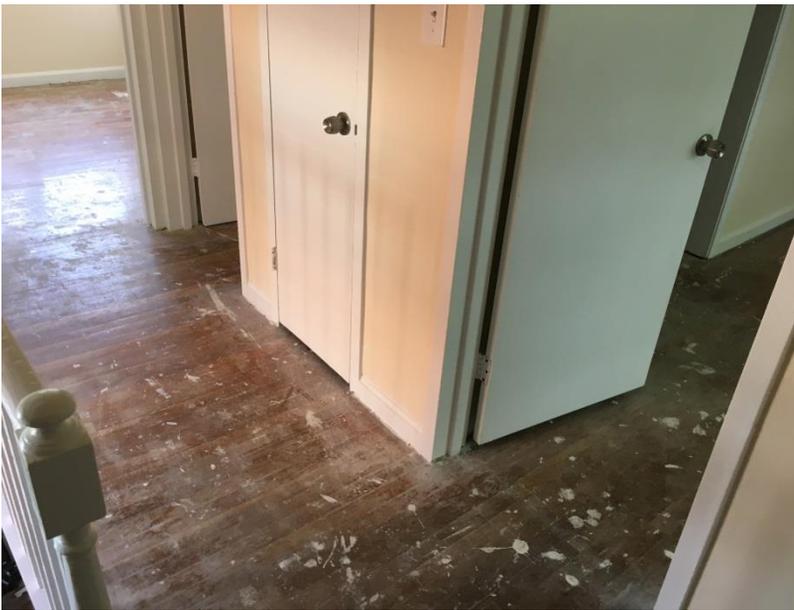
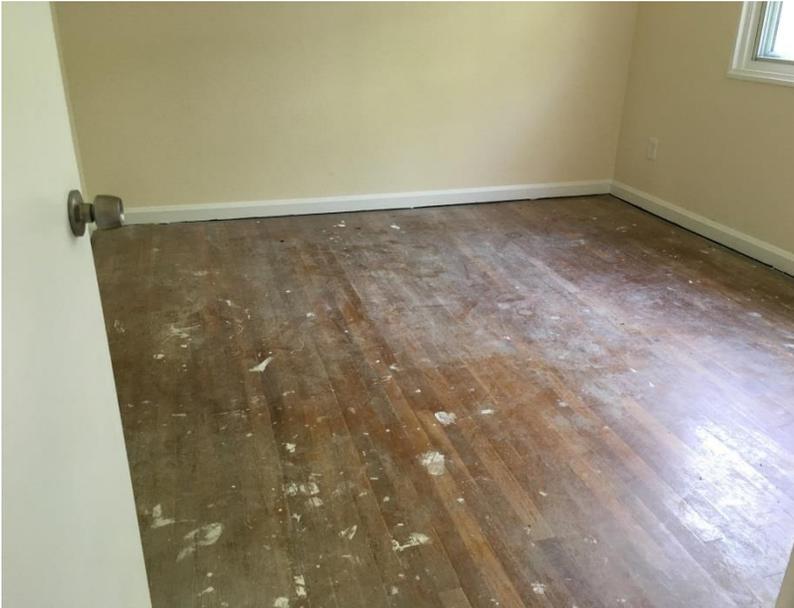
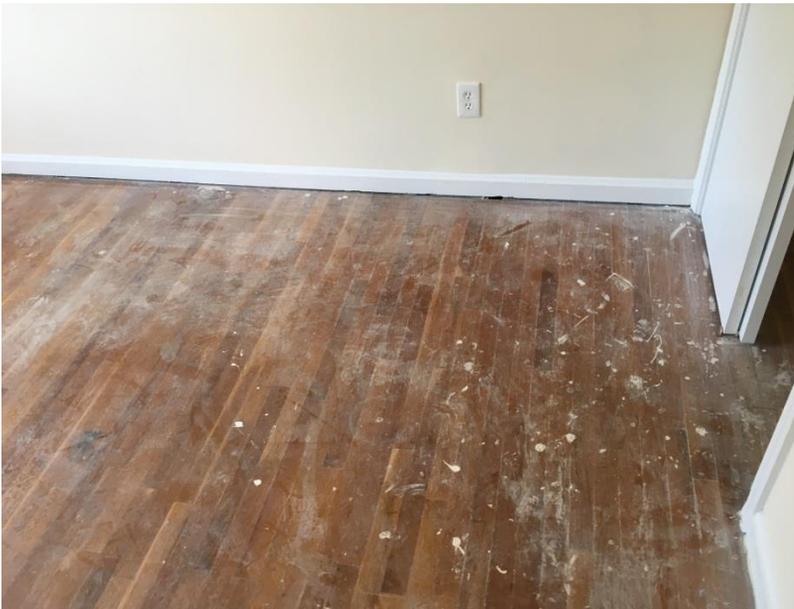
There can not be any visible dust inside of the home.

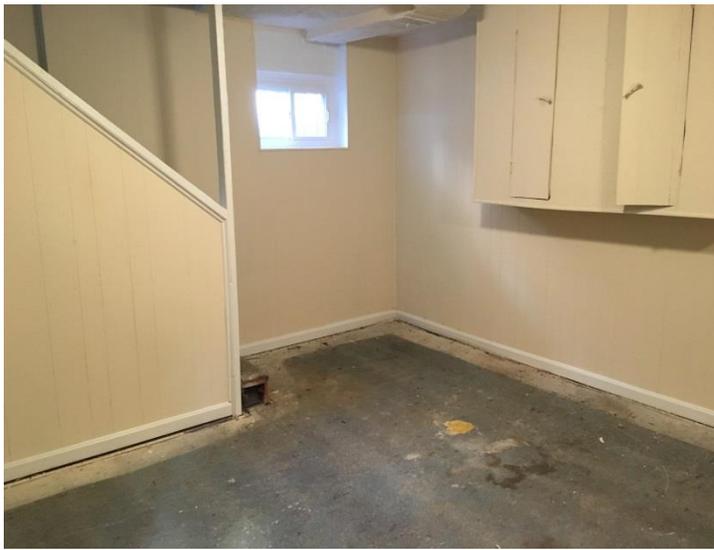
Dust, chipped paint,
and peeling paint found
throughout the
basement.

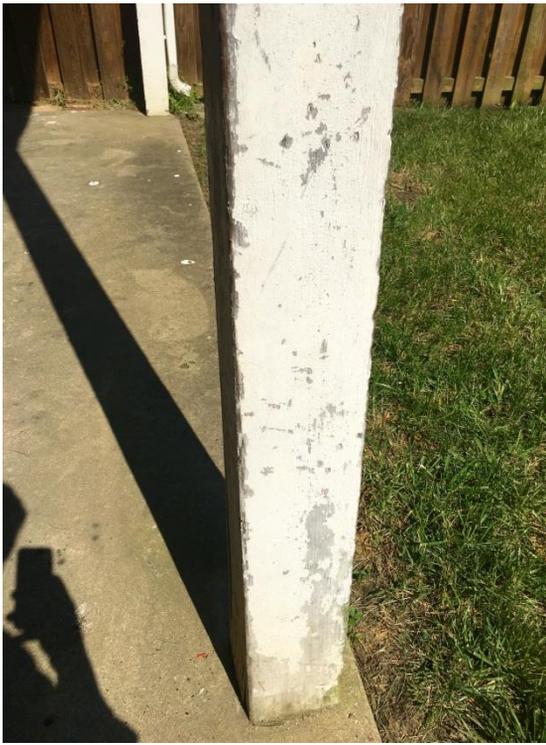
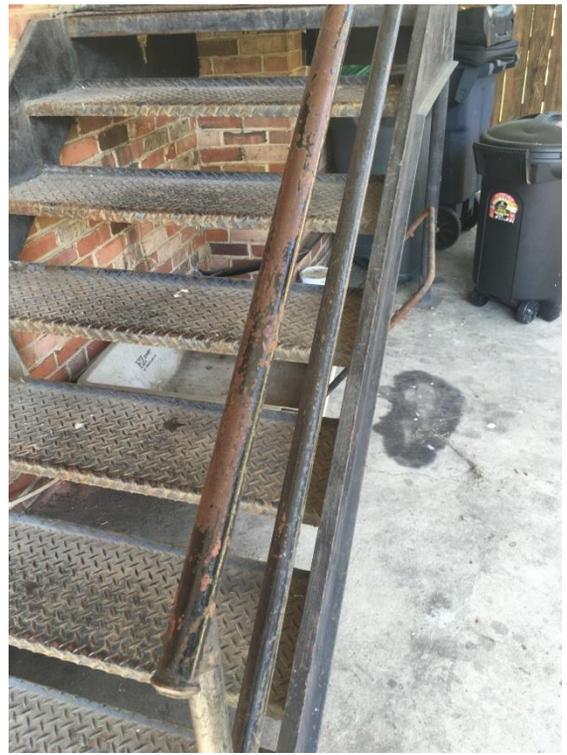
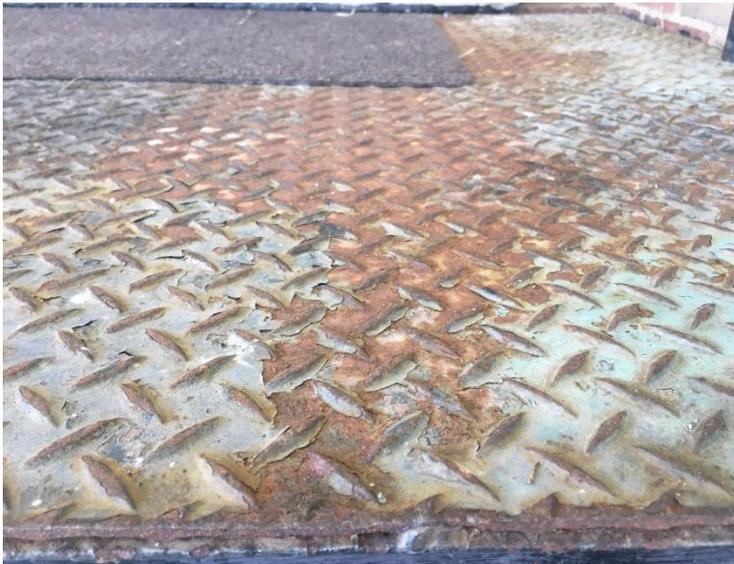
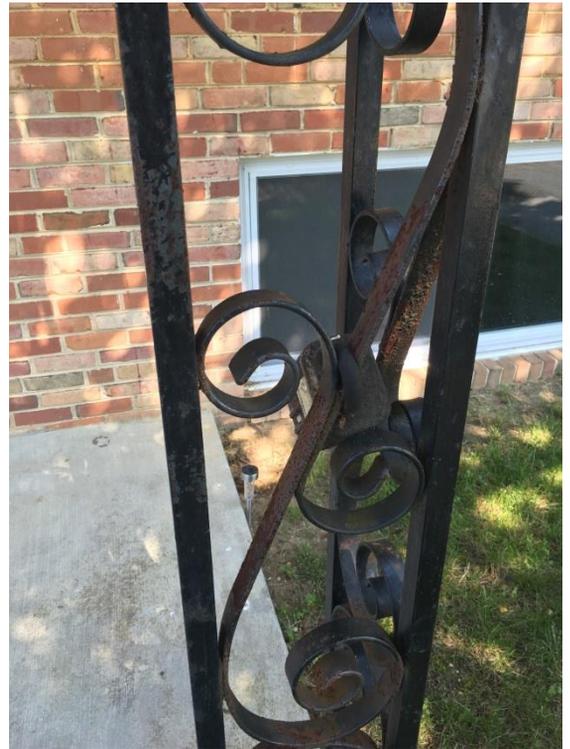
The wooden and metal columns outside the home have deteriorated paint on them. Also, the metal stair have deteriorated paint on them.

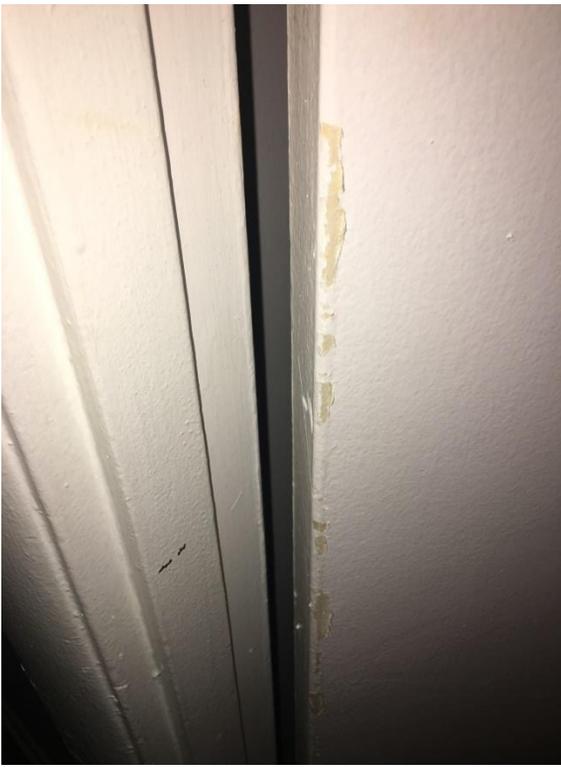
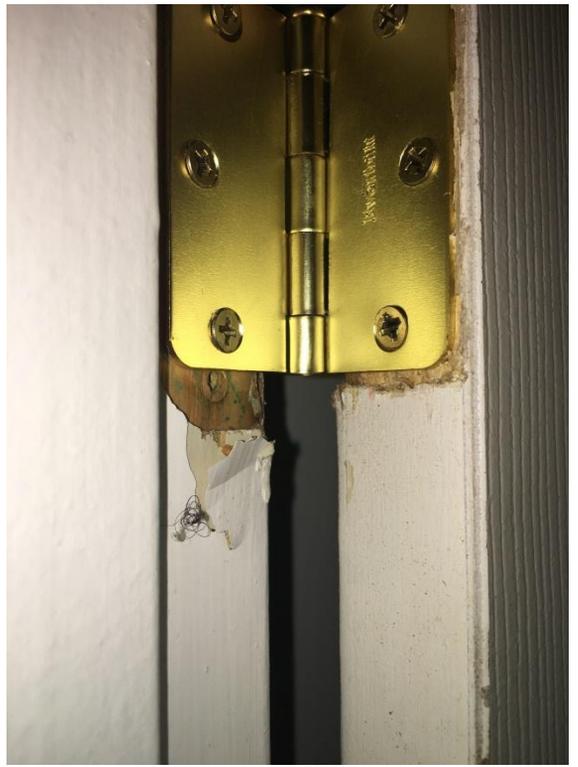
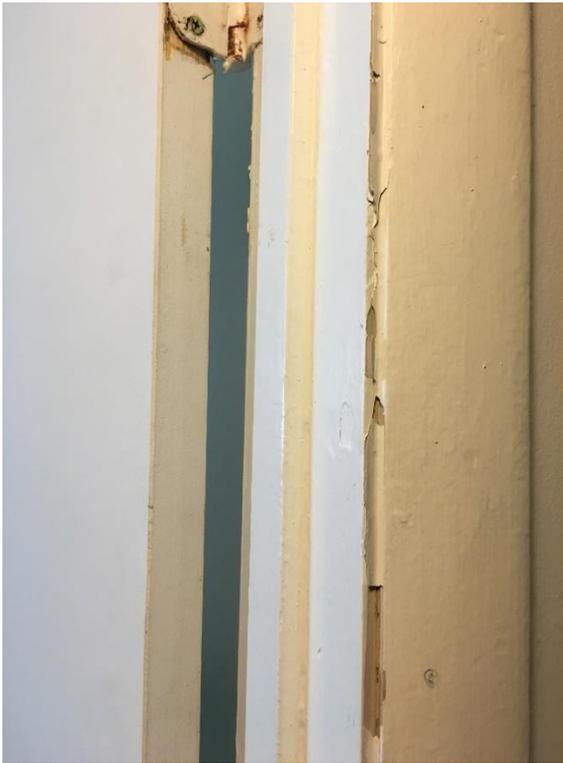
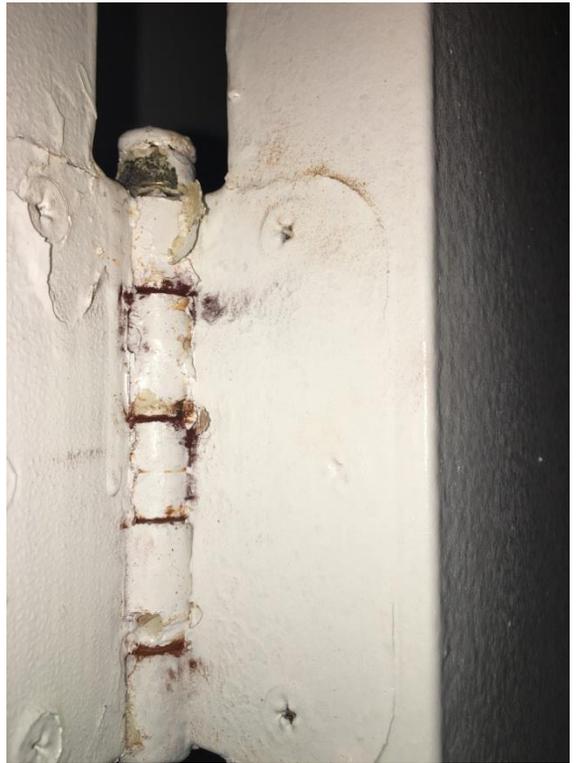
There was chipping and peeling paint around door frames throughout the home.

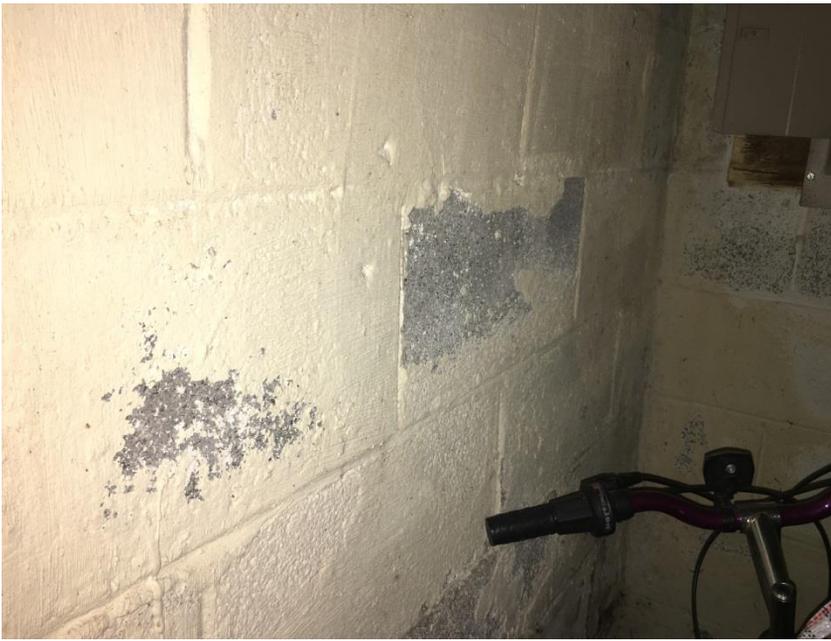
Paint was peeling/deteriorating along a wall in the laundry room.

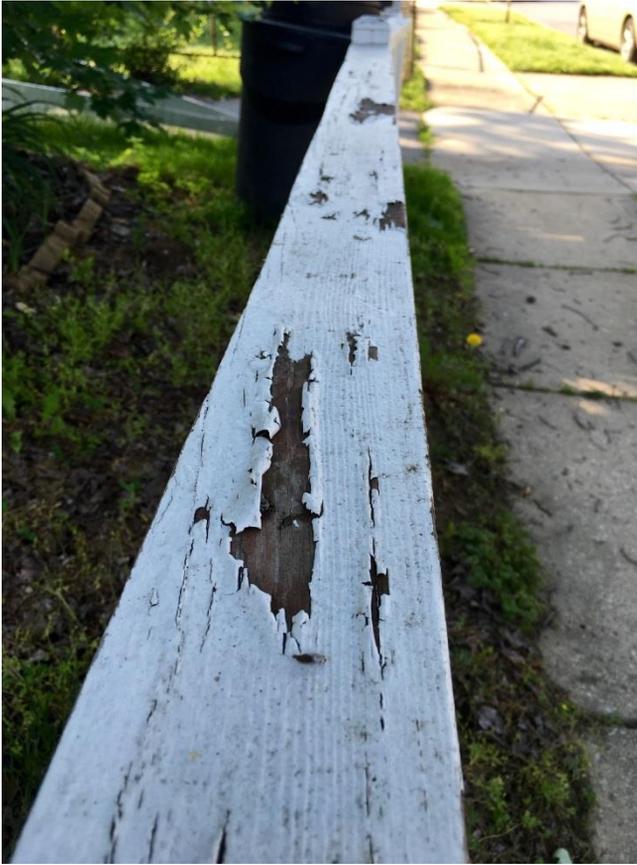
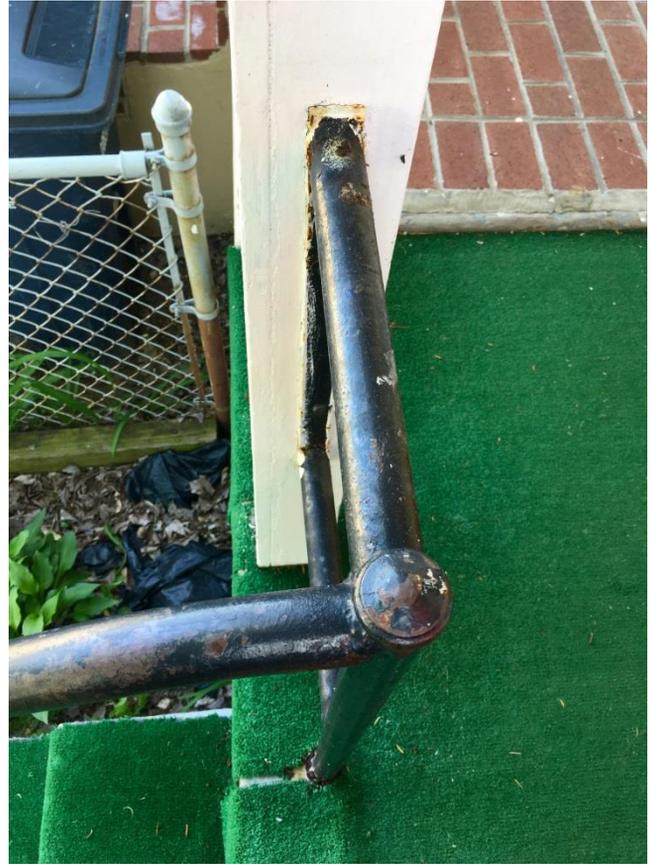
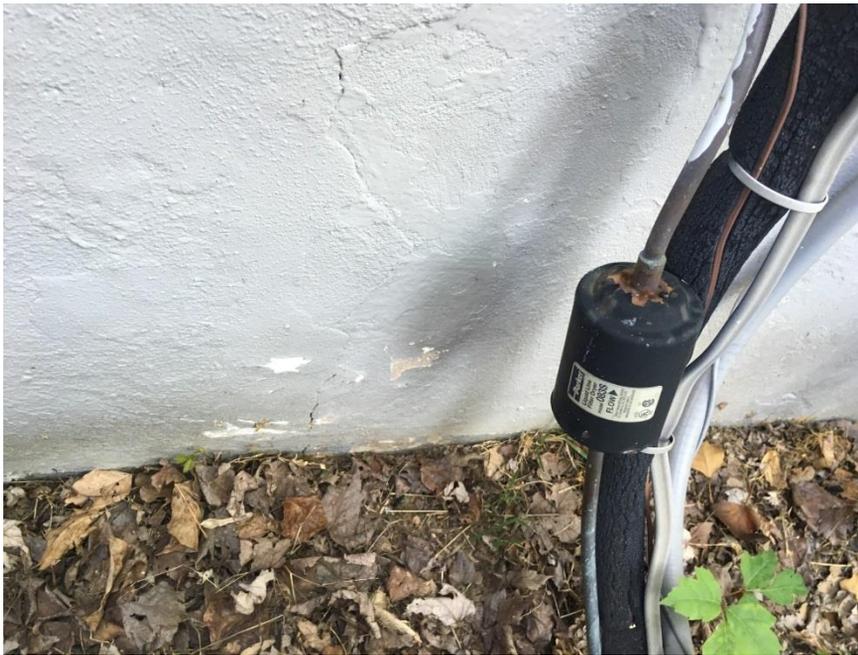
Painted surfaces along the fence, railing and wall outside of the home are deteriorating.

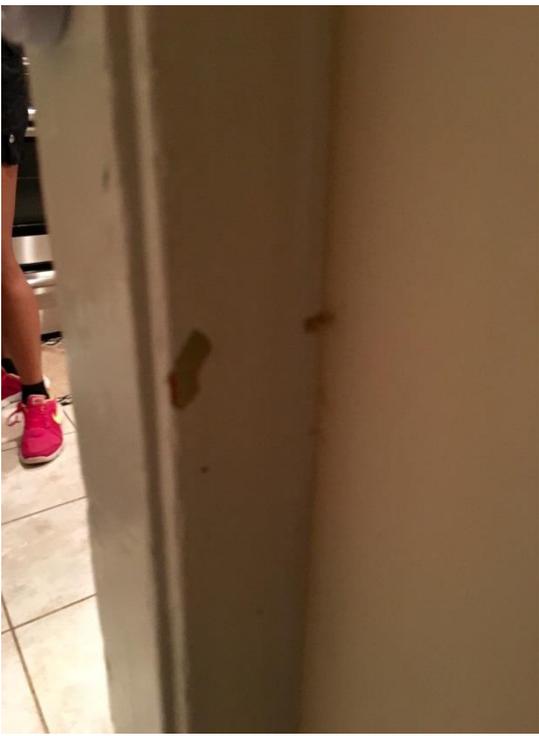
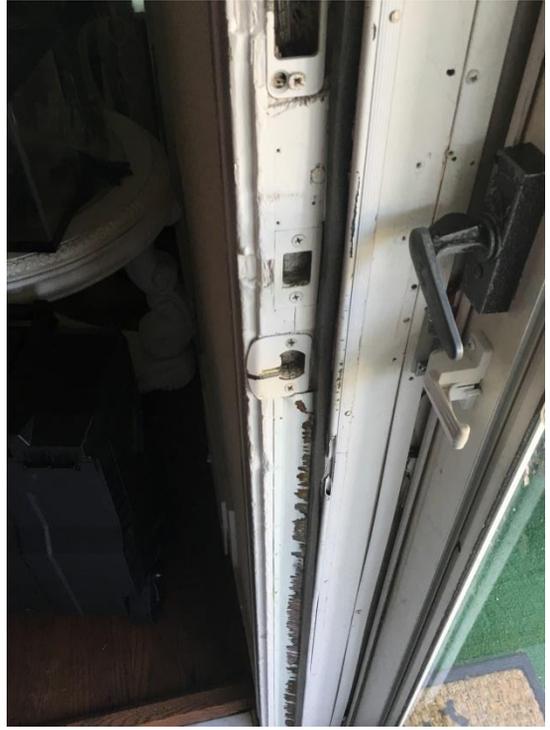
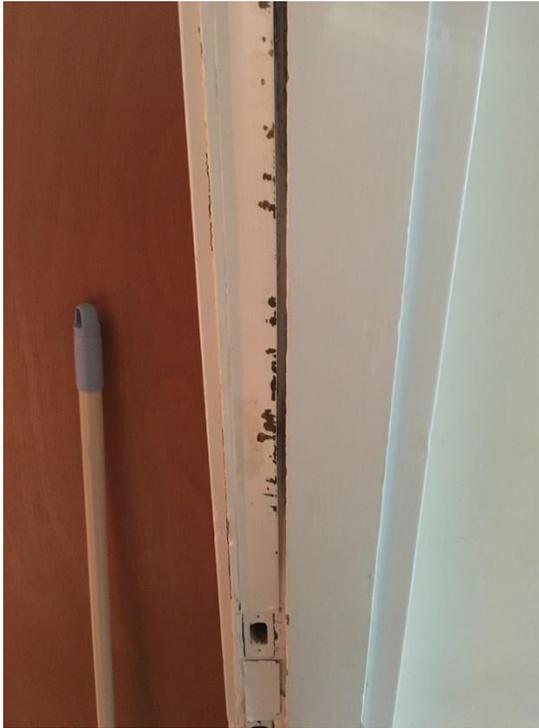
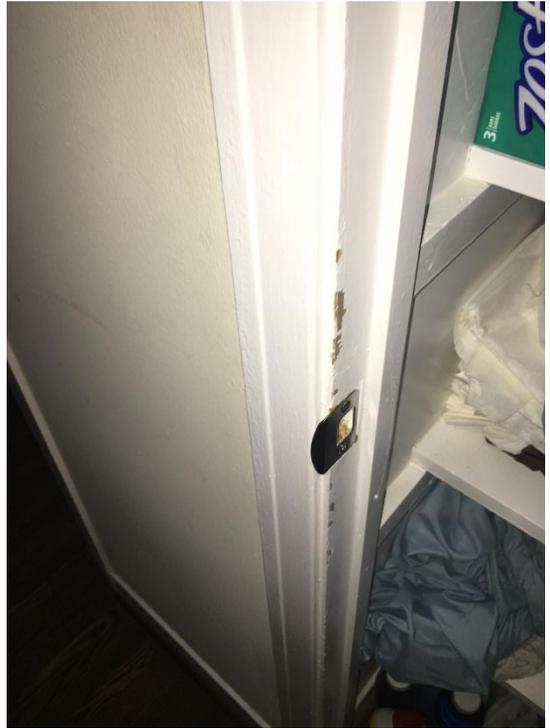
Paint is damaged around doorways and frames throughout the home.

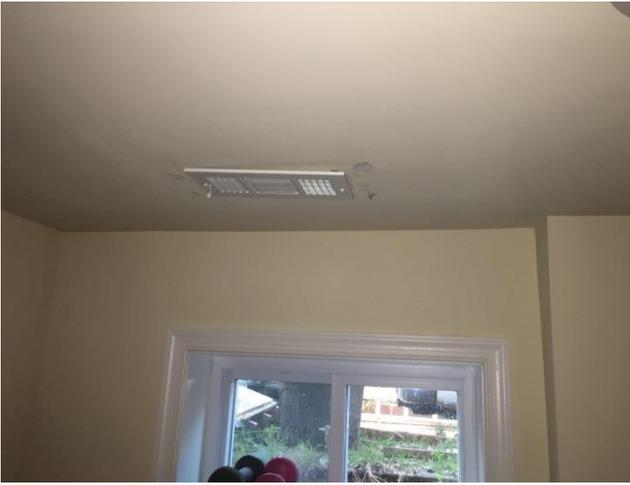
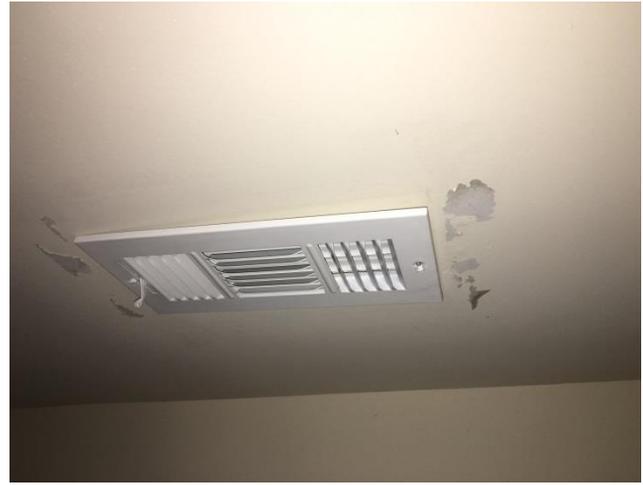
Paint is peeling off the roof in the basement around an air vent.

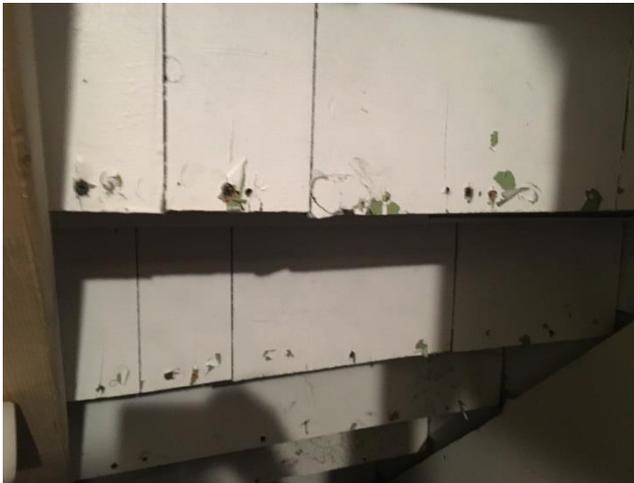
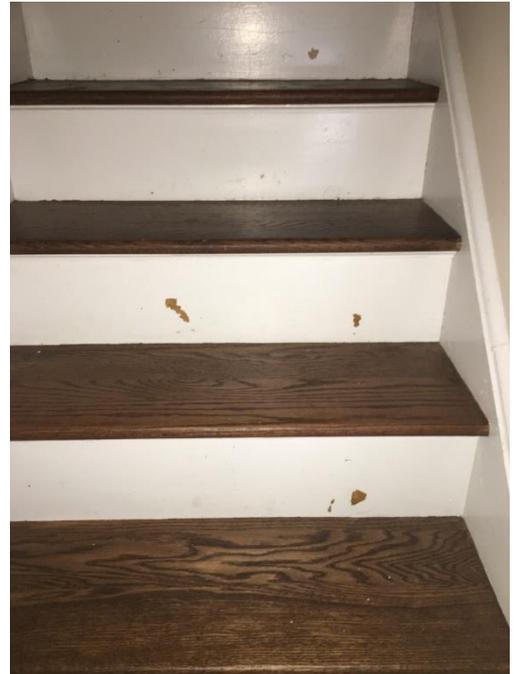
Paint is peeling off surfaces below the stair in the laundry room. Paint is also damaged on the back board of the stairs leading to the upstairs.
