SAMPLE DUST SAMPLING  
INSPECTION REPORT

FORM C - DUST INSPECTION

# 1234 Main Street – Unit 000 – Any Town, ST 0000

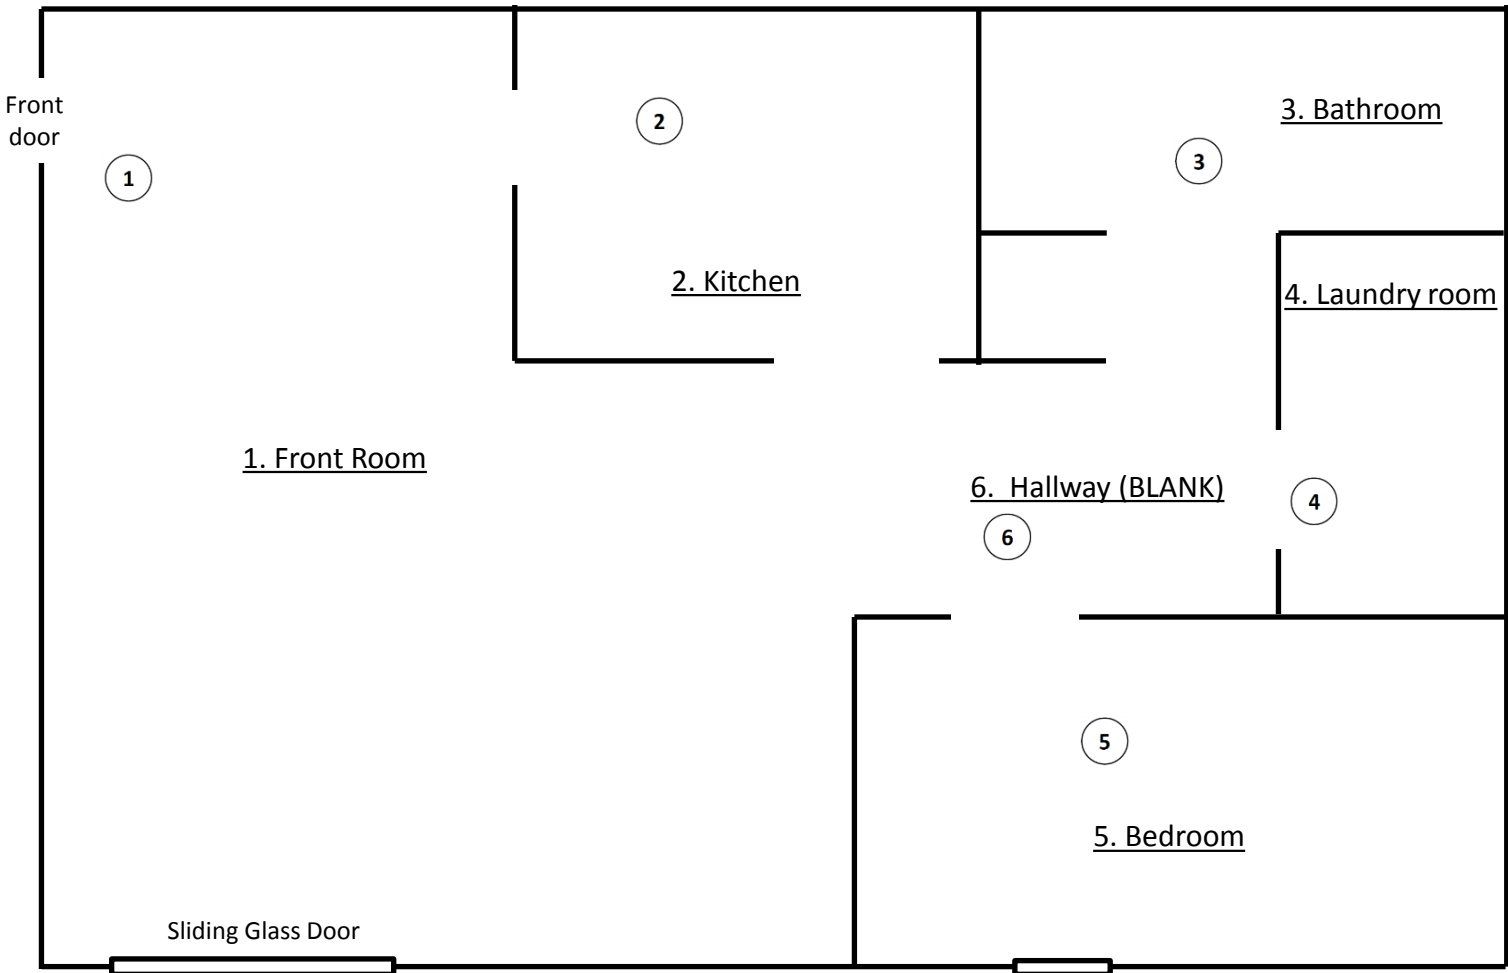
Location of Windows

Locations of Samples  
All samples are floors, 12" x 12"
